Merrimack County Courthouse Design and Space Planning

Study Summary Report
NH Project #80776

Building Evaluation

New Hampshire Trial Court Center
45 Chenell Drive
Concord New Hampshire

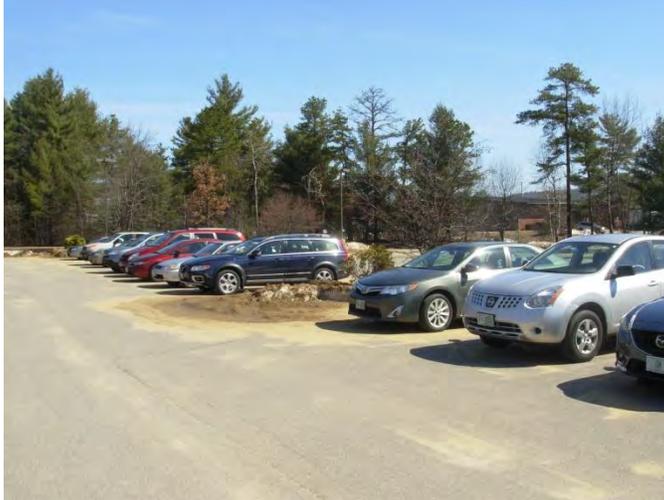
- The asphalt paving is in fair to poor condition with some cracking.
- The parking area is lighted with pole lights that are spaced far apart suggesting light levels at night may be low.
- An emergency generator is located between the sidewalk and the east side of the building. This was reported to have been added by the current primary tenant.

Parking lot

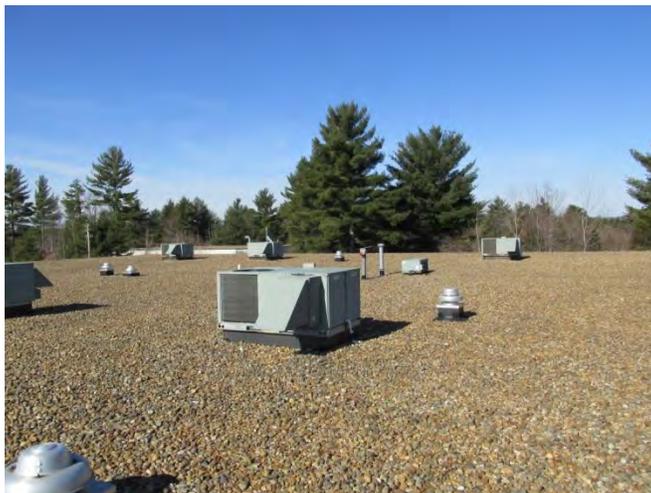
Existing packaged rooftop HVAC units are constant air volume units, serving one temperature control zone per unit. HVAC units were manufactured in 1998. HVAC units show signs of rust and general weathering, but appear to be in relatively good condition for their age. Existing HVAC units do not meet International Energy Conservation Code minimum cooling efficiency requirements. Exhaust fans show signs of rusting on the fasteners, but appear to be in overall good condition.

Roof with roof top HVAC equipment

- Existing packaged rooftop HVAC units are nearing the end of their expected lifespan and should be replaced. Existing HVAC units do not meet Energy Conservation Code minimum cooling efficiency requirements. Assuming interior wall layout and space programming remain unchanged, existing HVAC units may be replaced with new packaged rooftop HVAC units that meet International Energy Conservation Code heating and cooling efficiency requirements and provide the same level of control and comfort as the current equipment. Curb adapters will be required to allow new HVAC units to be located on existing roof curbs, however, with a new roofing system to be installed, new roof curbs are an option.

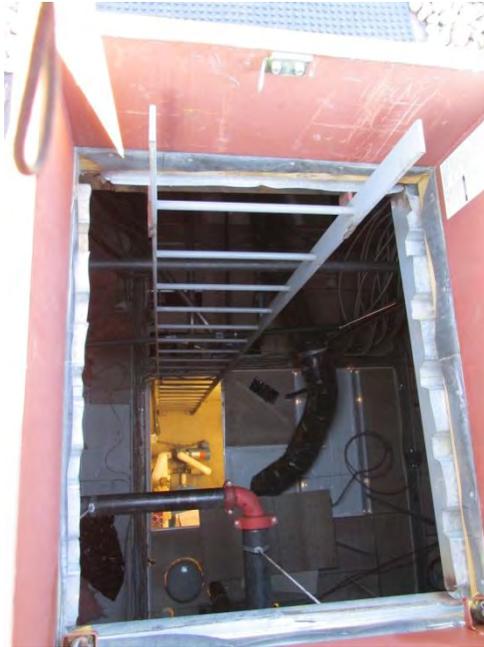
Roof hatch and access ladder

- A roof ladder which exceeds 24'-0" in height and requires a "cage" or safety features meeting OSHA regulations. This building's roof ladder is just below the limit, and so any safety accommodation that could be considered would be beneficial. A safety cage above 16' height would be beneficial. A safety post at roof hatch is recommended.

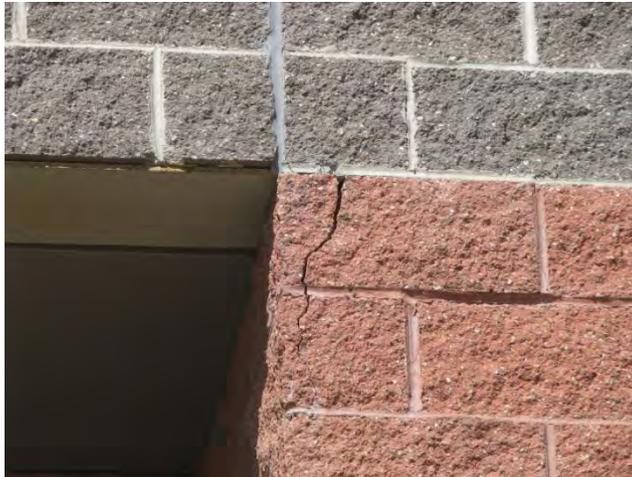
- Efflorescence and rust occurs at the lintel over the main entrance.
- Sealant in masonry control joints is cracked at some locations.
- A crack was observed in the CMU where a lintel ties into the wall above the loading dock.

Crack in CMU above loading dock

- Crack in CMU above loading dock needs to be repaired- see structural narrative.
- Building sealants have a limited life and should be inspected each year. Typically, urethane sealants will need replacement every 8 - 12 years. Silicone sealants can last twice this time. Existing sealants in masonry walls have failed in places showing that sealants installed have reached the end of their service life, and so should be replaced with silicone sealants.

- *Exterior CMU bearing walls.*
At one location near the loading dock lintel (ref. photo 3893) there is an isolated crack approximately 16" x 3/8" wide. This crack should be filled to prevent water infiltration and subsequent freeze-thaw cycles.

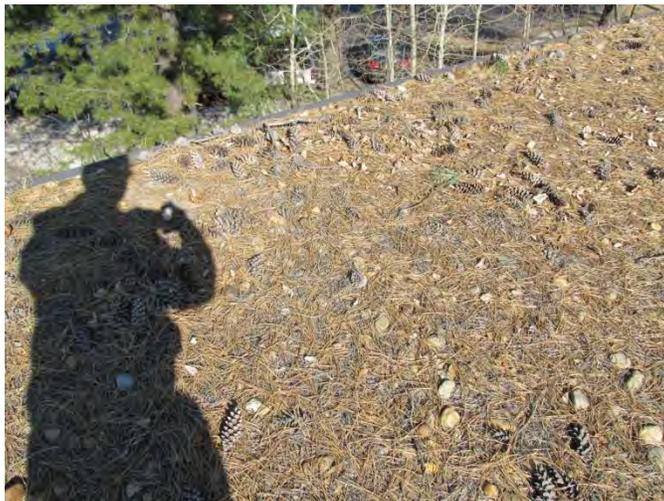
- The ballasted EPDM roof is in good condition for its age and drains to roof drains aligned with the column grid running the length of the building. At some locations pine needles have accumulated at the roof edge and adjacent roof drains.

Debris on roof along roof edge

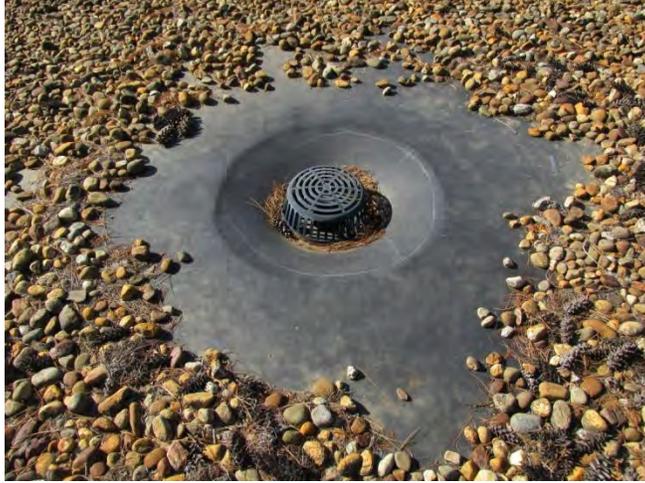
Debris in roof drain

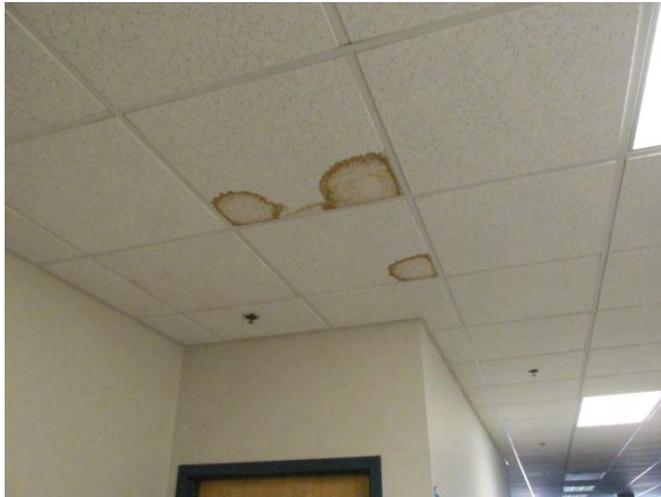
- Ceilings are 2'-0" by 2'-0" acoustical panel ceilings, typically at 8'-10" A.F.F. and in good condition except where leaks have occurred above the ceiling and stained tiles.

Ceiling tiles stained by leak above

- Leaks above stained ceiling tiles should be traced to find origin and repaired. This effort will be superseded by the installation of a new roof.
- ADA non-compliant conditions described above should be rectified.
 - If a lobby visitor is required to complete forms or sign-in, then an accessible writing surface is required.

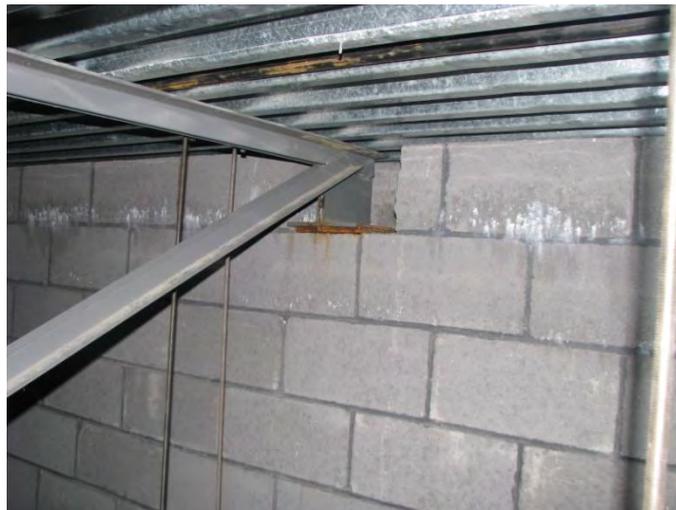
- Efflorescence occurs in a continuous band at the top of the exterior wall. Efflorescence is typically the result of wetting of the masonry, dissolution of salts within the material, and the subsequent transportation and deposition of those salts on the masonry surface when the moisture evaporates. Thus, at some time, the masonry in this location was wetted, though no apparent wetting was apparent during observation for this report.

Bar joist bearing on CMU wall and continuous line of efflorescence

- The tops of exterior walls should be monitored for wetting at various weather and humidity conditions to possibly determine the source of moisture which caused efflorescence.

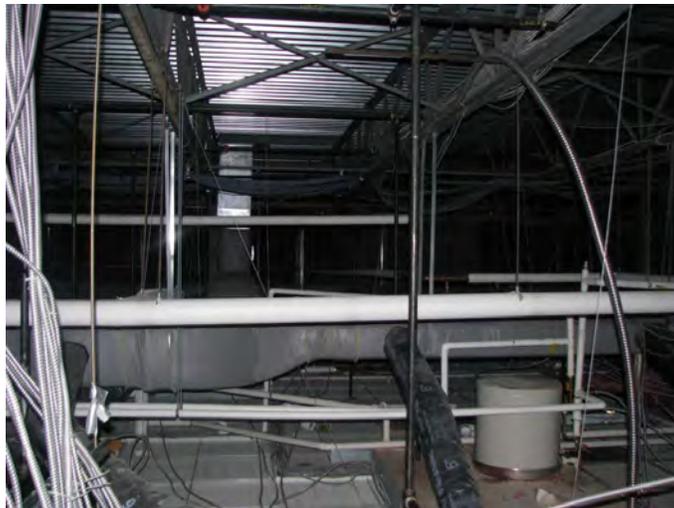
PVC plumbing vent piping in plenum

- Replace existing sanitary vent piping within the plenum with cast iron or copper piping. Alternatively and where pipe routing permits it, the plastic piping can be enclosed within a wall.

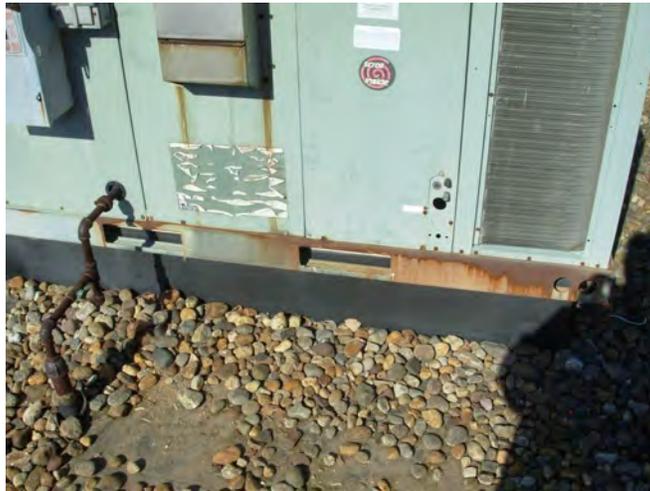
The natural gas regulator and meter are located on the building exterior. The regulator reduces natural gas from street pressure (60 psig) to 7" water column pressure. Natural gas distribution piping runs in the ceiling plenum with individual roof penetrations for each packaged rooftop HVAC unit. Natural gas piping above the roof does not appear to be painted and shows a considerable amount of rust.

Packaged roof top unit and gas piping

- Replace existing single level drinking fountain with new bi-level, ADA compliant drinking fountain.
- Paint exposed natural gas piping on roof.

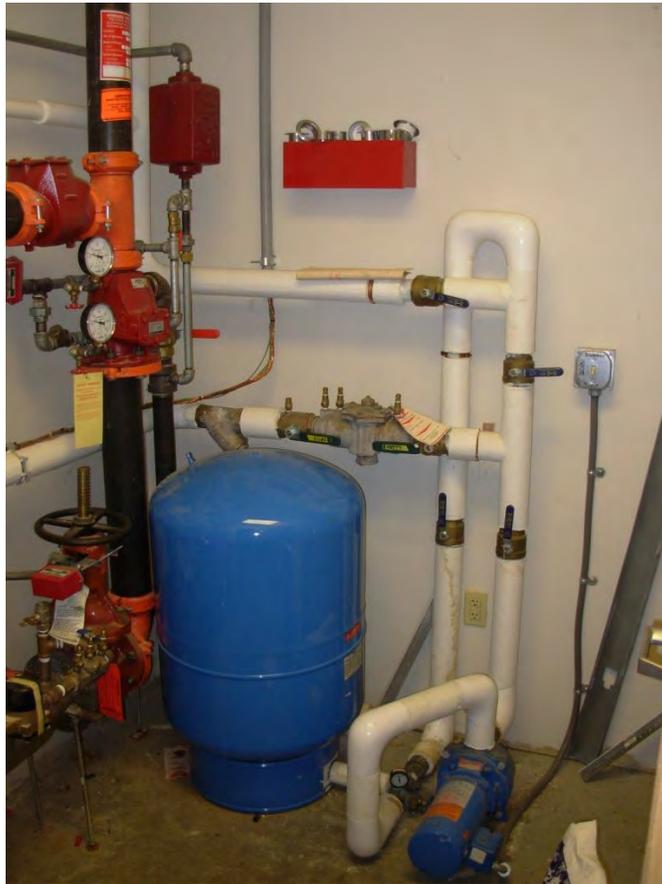
Domestic water booster pump

- Explore whether or not existing domestic water booster pump is required. At 65 psi pressure, the system should be able to flush toilets and operate other fixtures. Perhaps the service was improved subsequent to building construction, or perhaps service pressure is unreliable. Repair pump system if required. Remove pump system if not required.
